# NAVAL RESEARCH LABORATORY REPORT

Report R-3036

REMOVAL OF EASE REFLECTIONS BY HARP  
IN THE SG INSTALLATION ABOARD DESTROYERS

A study has been made of the antenna patterns for the SG radar installation aboard a destroyer. The reflector and feed were of an improved design with side lobes approximately the same as those of the SG now under development (below 30 db). It is shown that side lobes as high as 21 db are introduced by mast reflections and that they may be eliminated by covering the illuminated section of the mast with Harp. The influence of such side lobes on the PPI presentation when large targets are nearby has also been studied and a marked improvement found with the mast reflections removed by Harp. It is concluded that the benefit derived from lower side lobes in an improved SG antenna can only be realized if provision is made to remove the mast reflections by Harp.

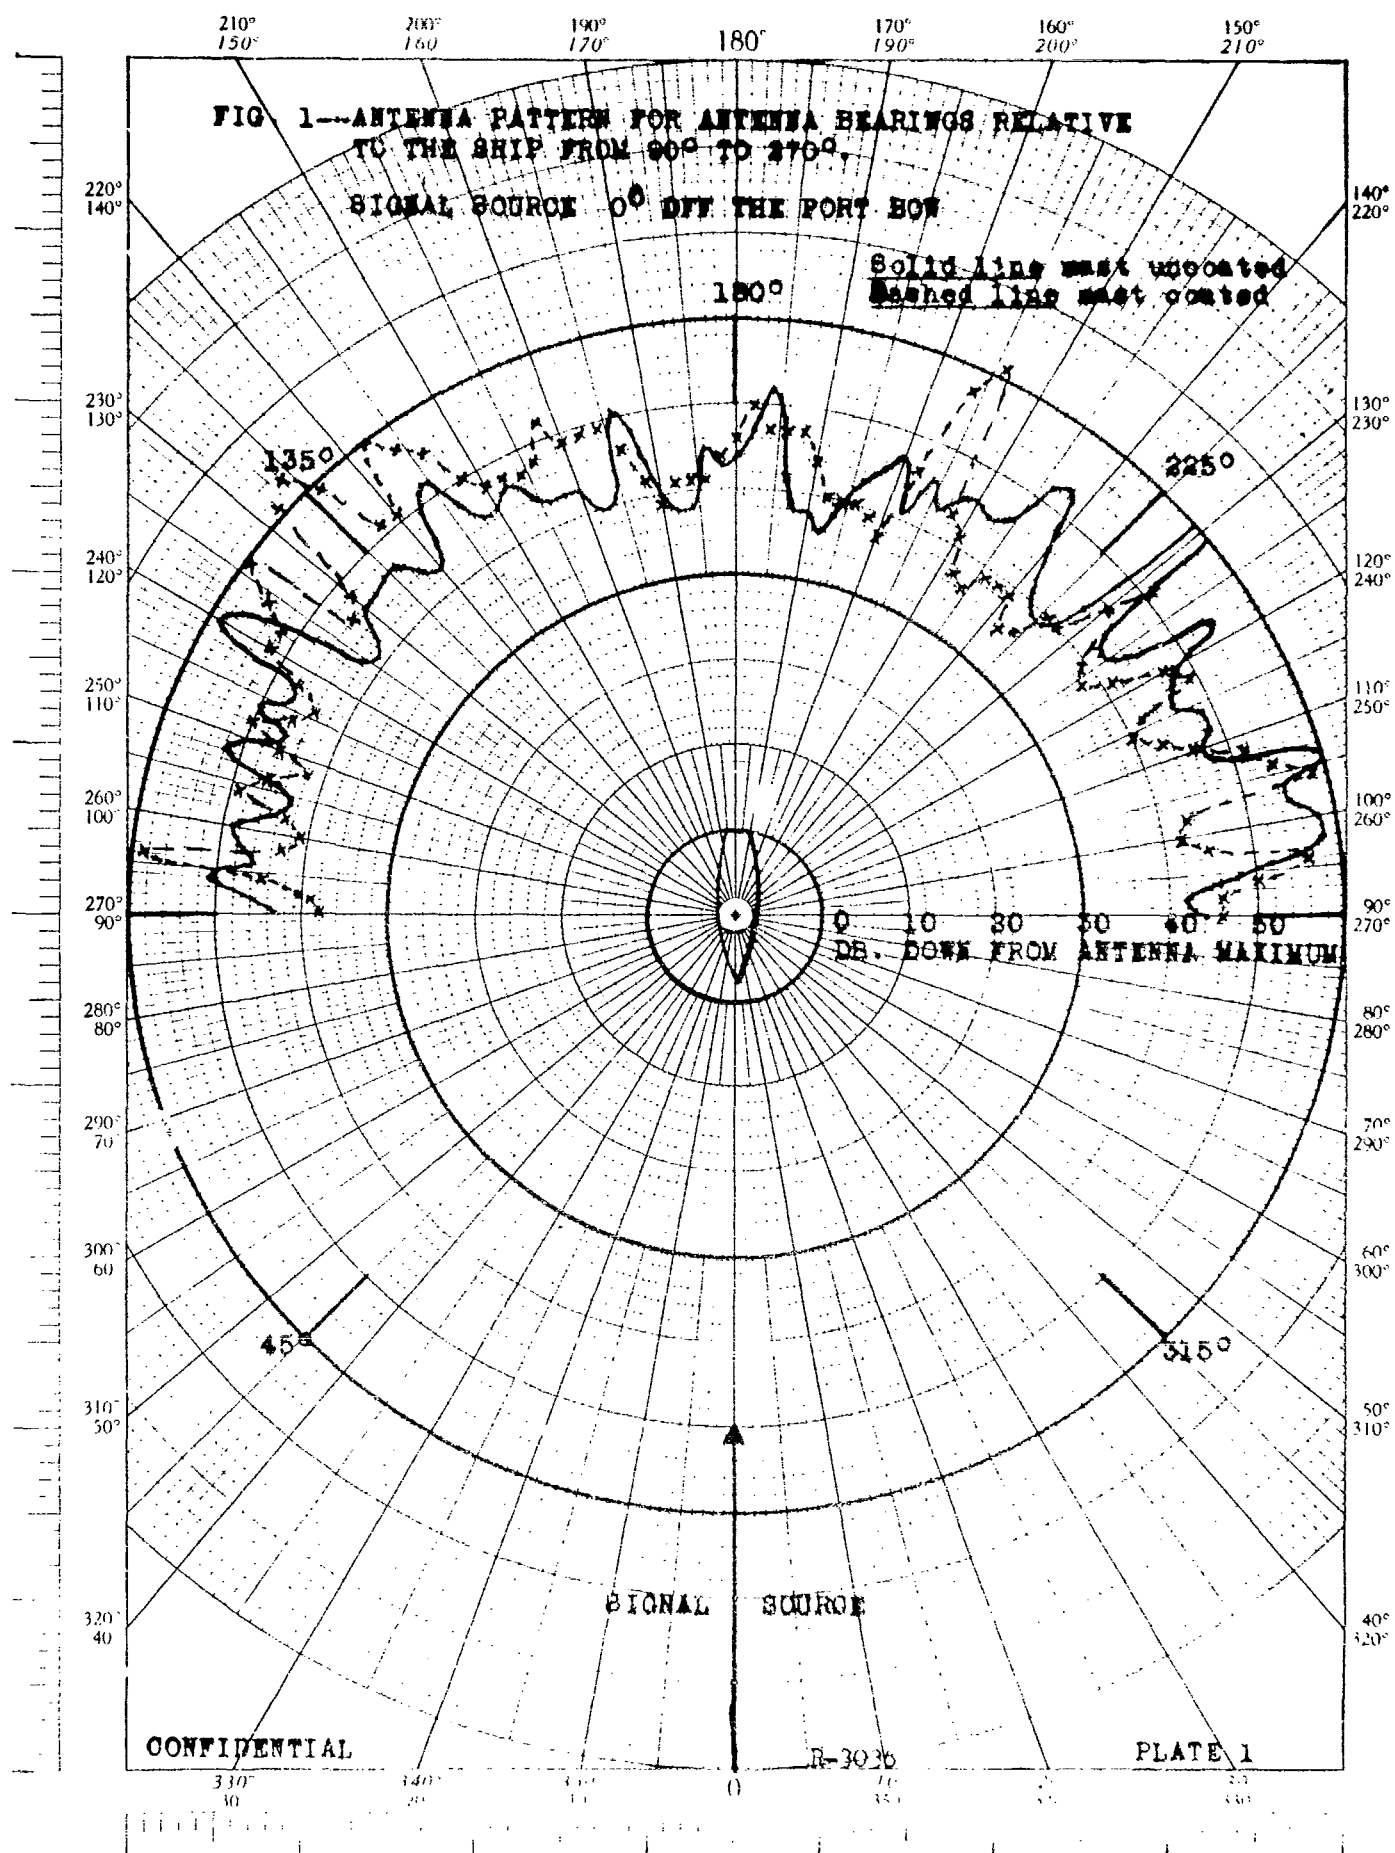
PLATE A

3.3. It will be noticed that the patterns do not exhibit the left - right symmetry that might be expected and was found in the previous tests. This is probably caused by the platform mentioned in paragraph 2.1 and marked by A in Plate A. This metallic structure intercepting a part of the beam on the port side of the mast can cause a substantial difference in the mast reflections on the port and on the starboard sides.
